Second Five-Year Review Report  
for  
Raymark Industries, Inc. Site  
Stratford, Connecticut

September 2005

The United States Environmental Protection Agency  
Region 1, New England  
Boston, Massachusetts

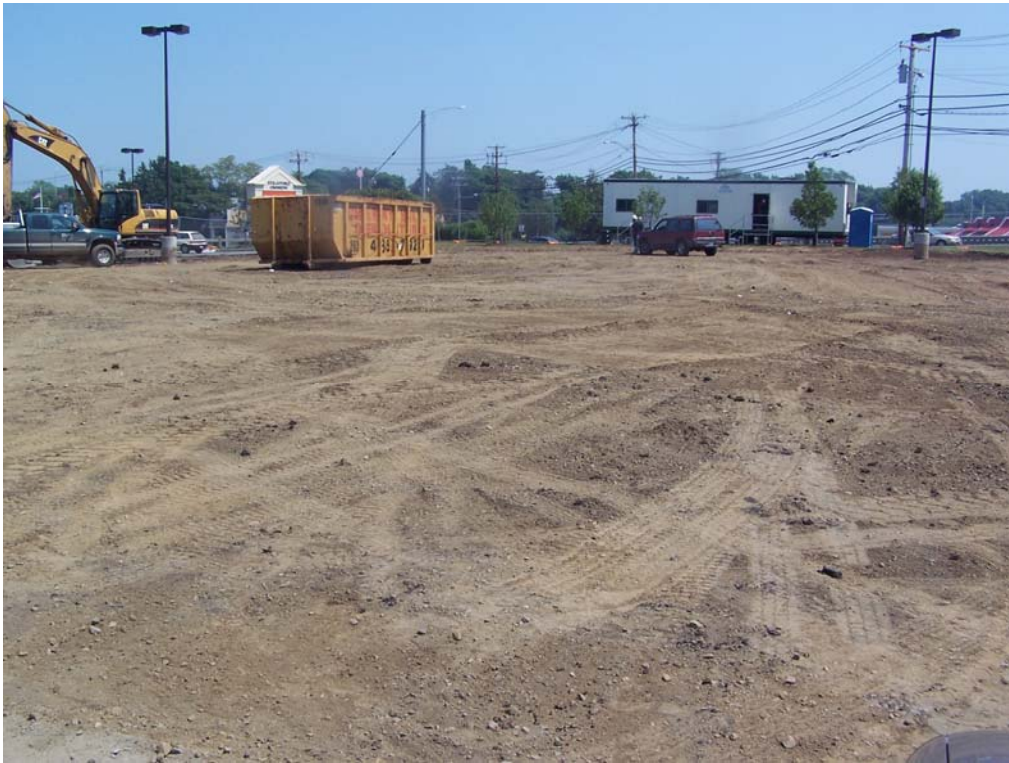
Construction of Webster Bank

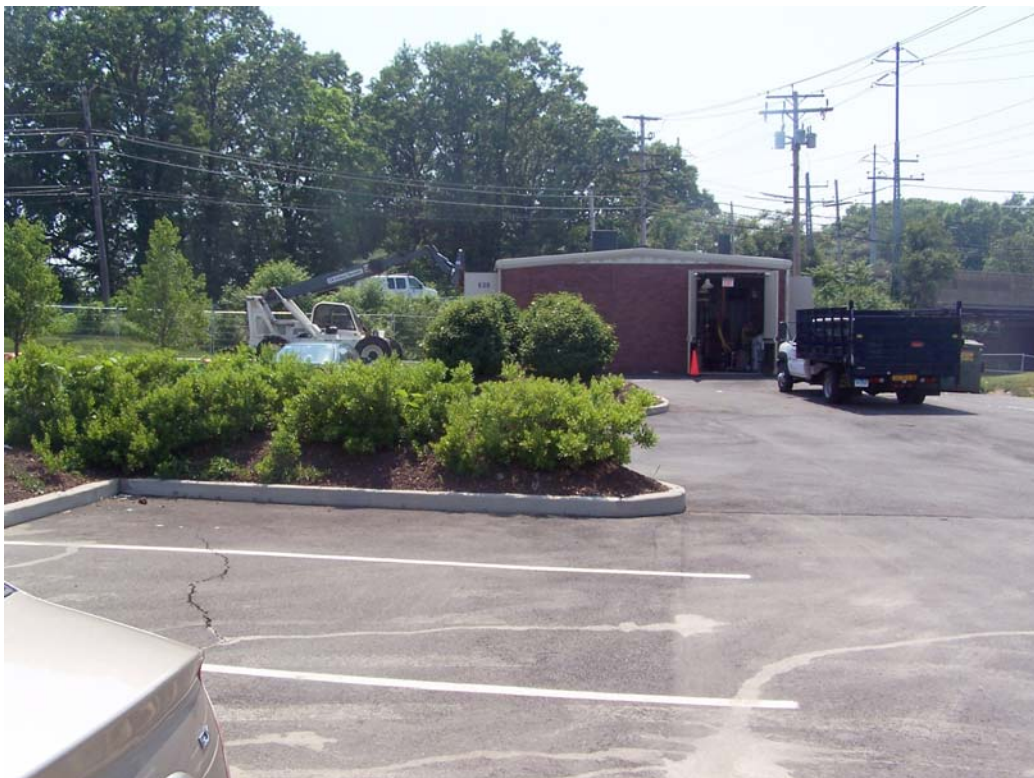
Western treatment building

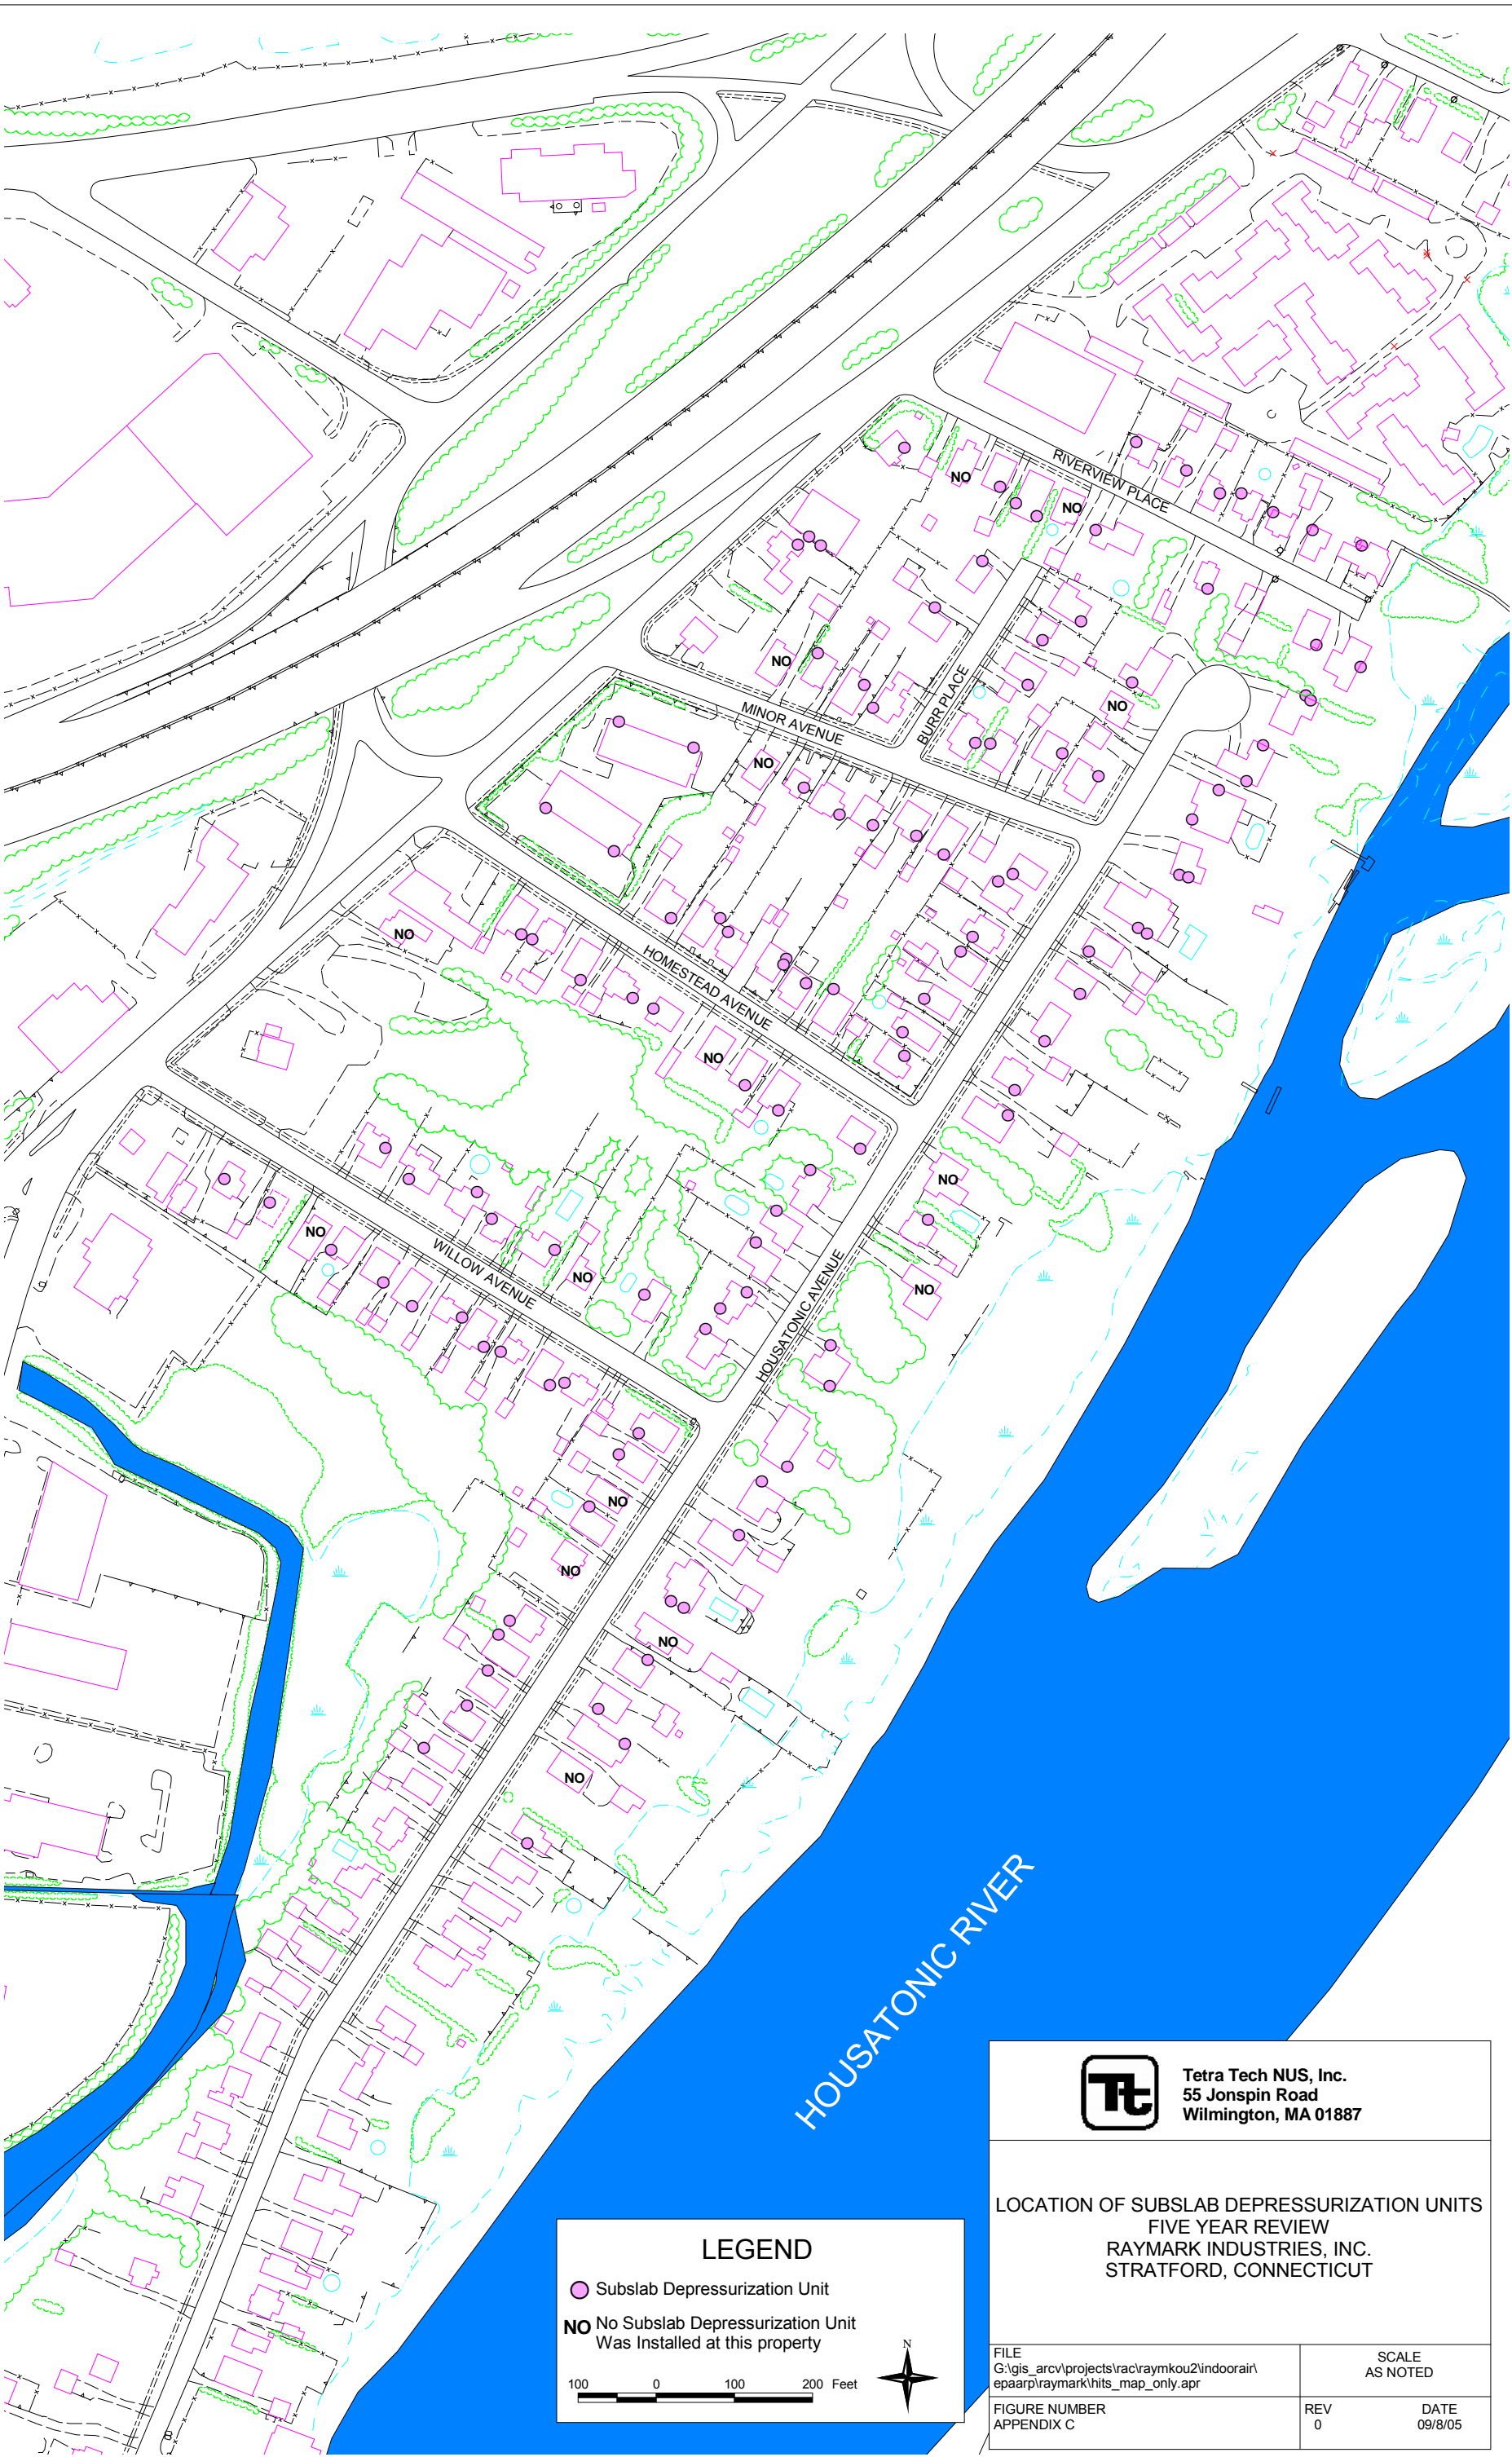
LOCATION OF SUBSLAB DEPRESSURIZATION UNITS  
FIVE YEAR REVIEW  
RAYMARK INDUSTRIES, INC.  
STRATFORD, CONNECTICUT

The location of the properties inspected are presented on the attached figure entitled “Location of Subslab Depressurization Units.” The location of each of the Subslab Depressurization Systems vent is indicated on the figure by a red dot. A total of 11 properties were observed to have two vents and blowers on the side of the building. These properties include the two apartment buildings located at 450 and 470 Ferry Boulevard, 85 Homestead Ave., a duplex house at 48/50 Riverview Place, and 320, 375, 520, 550, 560, 580, and 600, Housatonic Ave.

Two locations that are listed as having a Subslab Depressurization System but where a system vent was not observed are located at 53 Minor Ave. and 100 Riverview Place. The property at 53 Minor Ave. had no evidence of a vent system; however, subsequent conversation with Ron Curran indicates the system is in the attic. The property at 100 Riverview Place looked to have had extensive renovations done on the house. It is possible that either the system was disconnected for the renovations and not reconnected at the time of this site visit or the system has been removed.

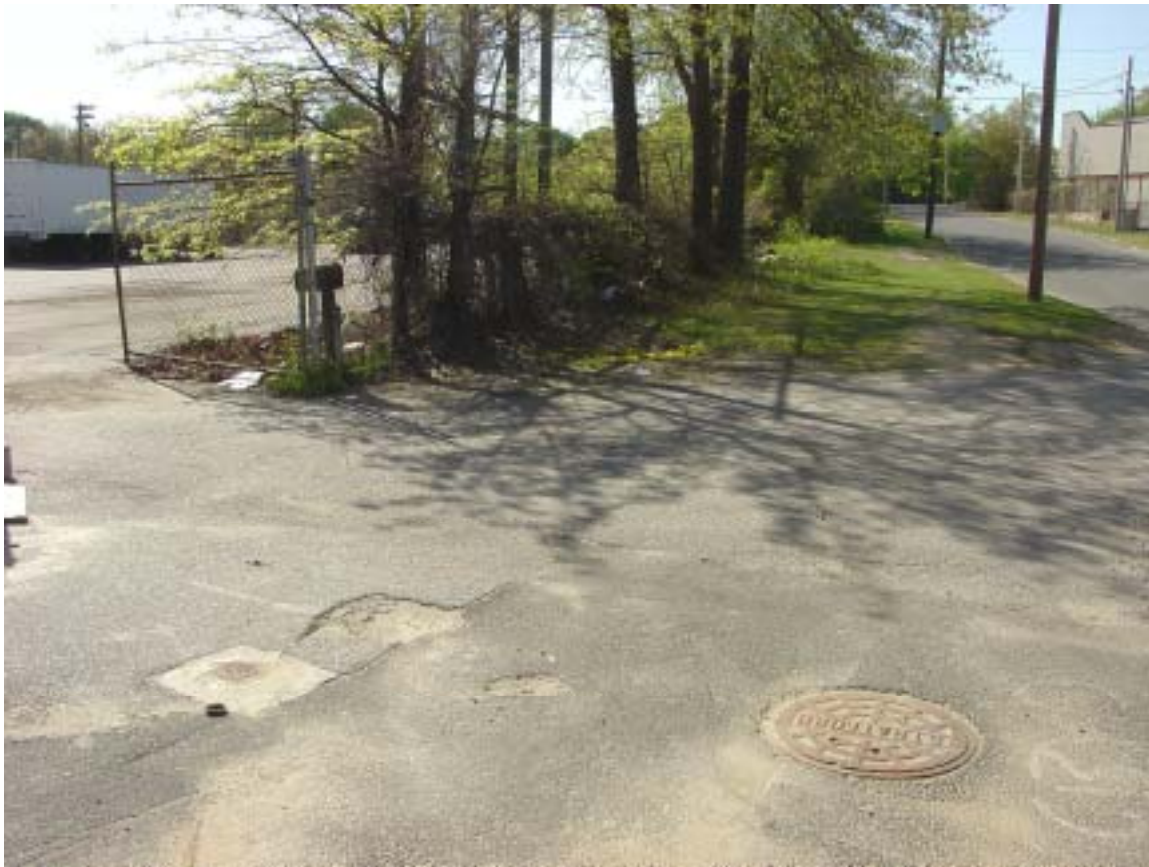
Entrance to OU4 Ballfield. Monitoring Well MW-521S shown on left side of photo; Frog Pond Lane shown on right side of photo

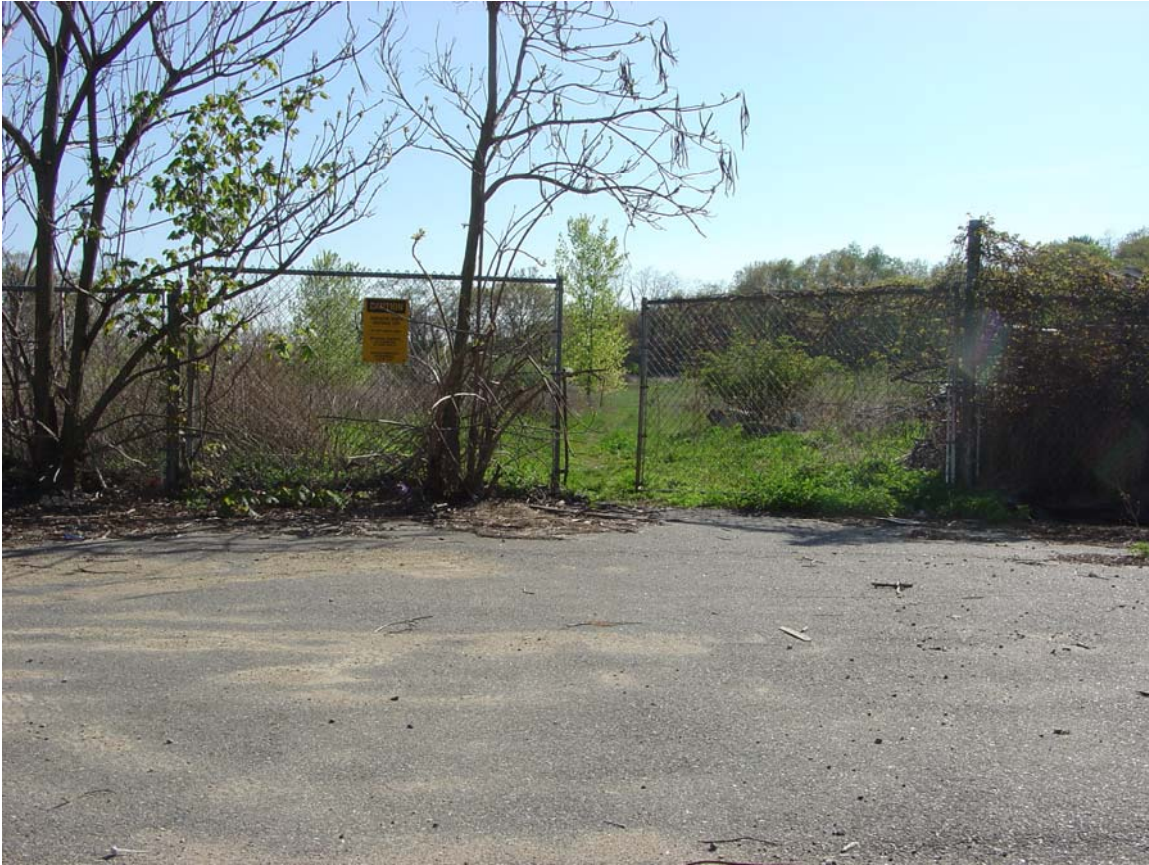
Monitoring well MW-3 was observed beneath the rear of one of these storage trailers. Warning signs placed on the interior fences between the parking area and soil covered fields were found in place but obstructed by heavy vegetation. The gate to the large open field was found unlocked and open with obvious signs of use based on the wear pattern and lack of growth.

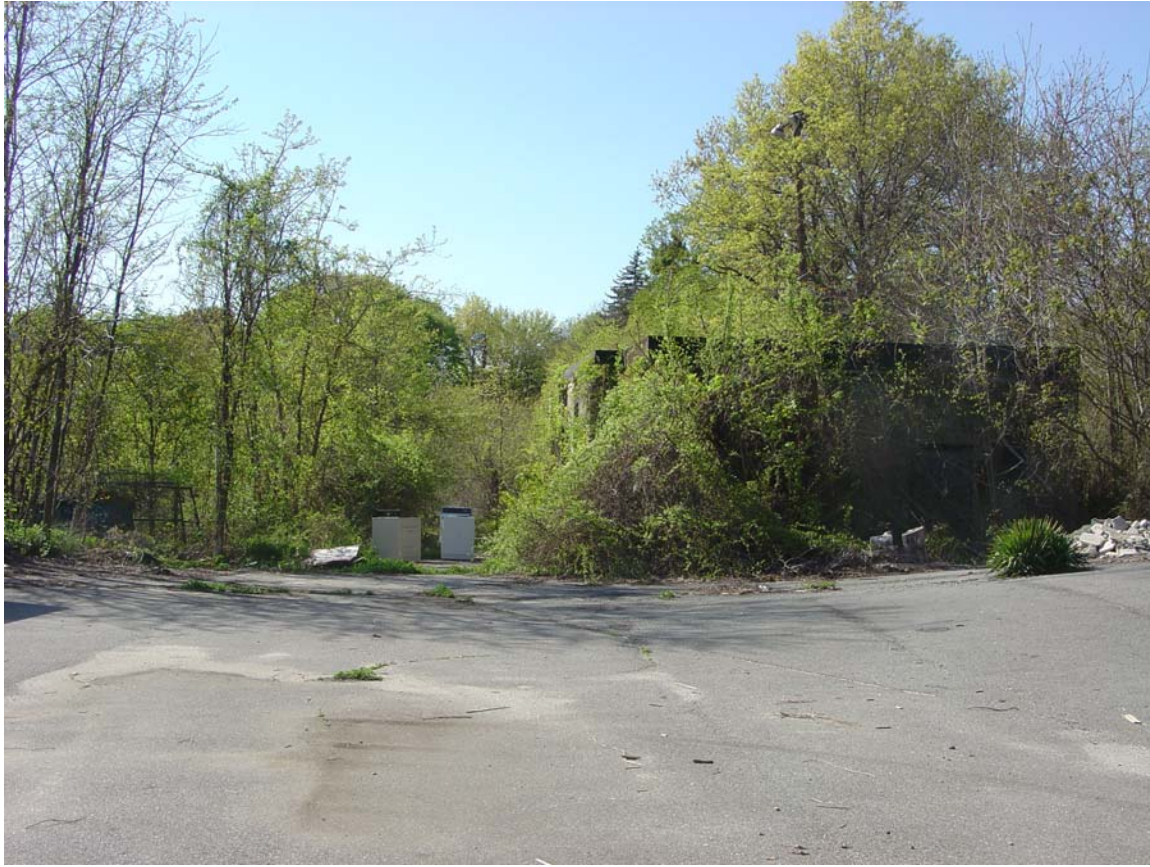
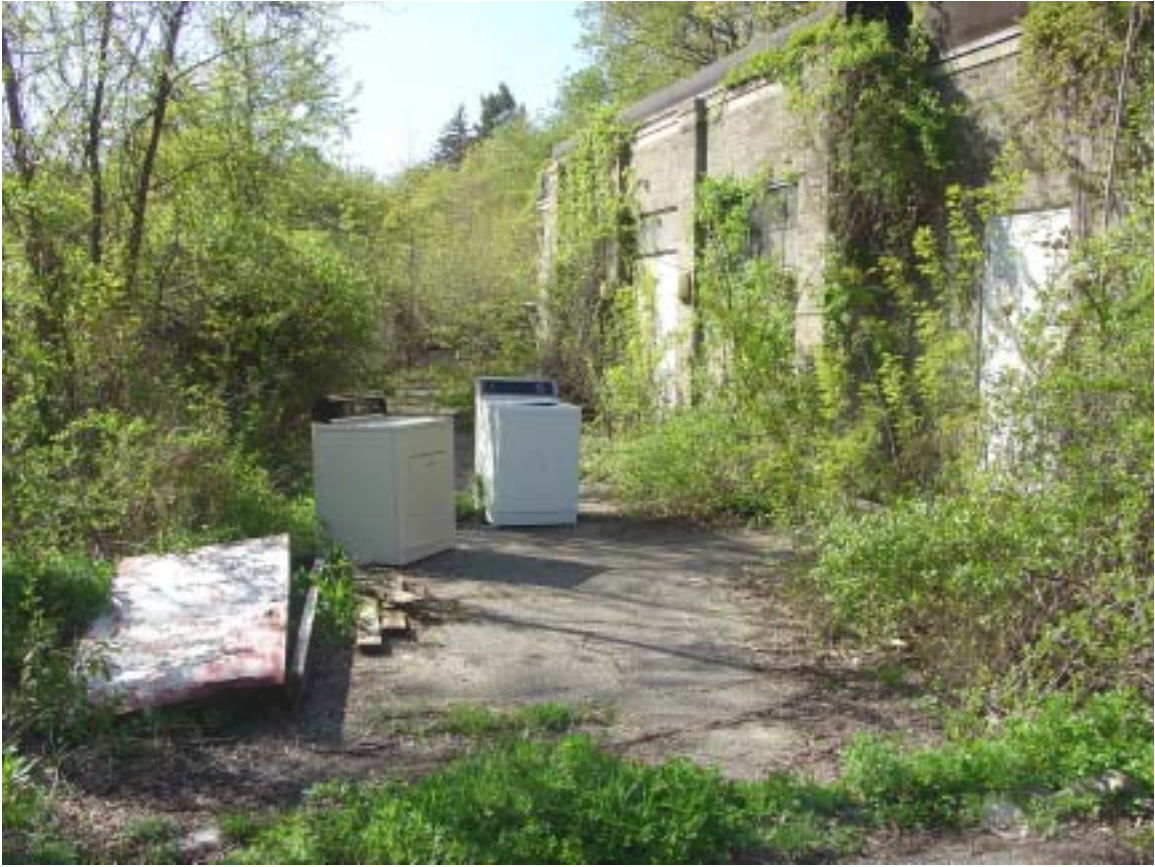
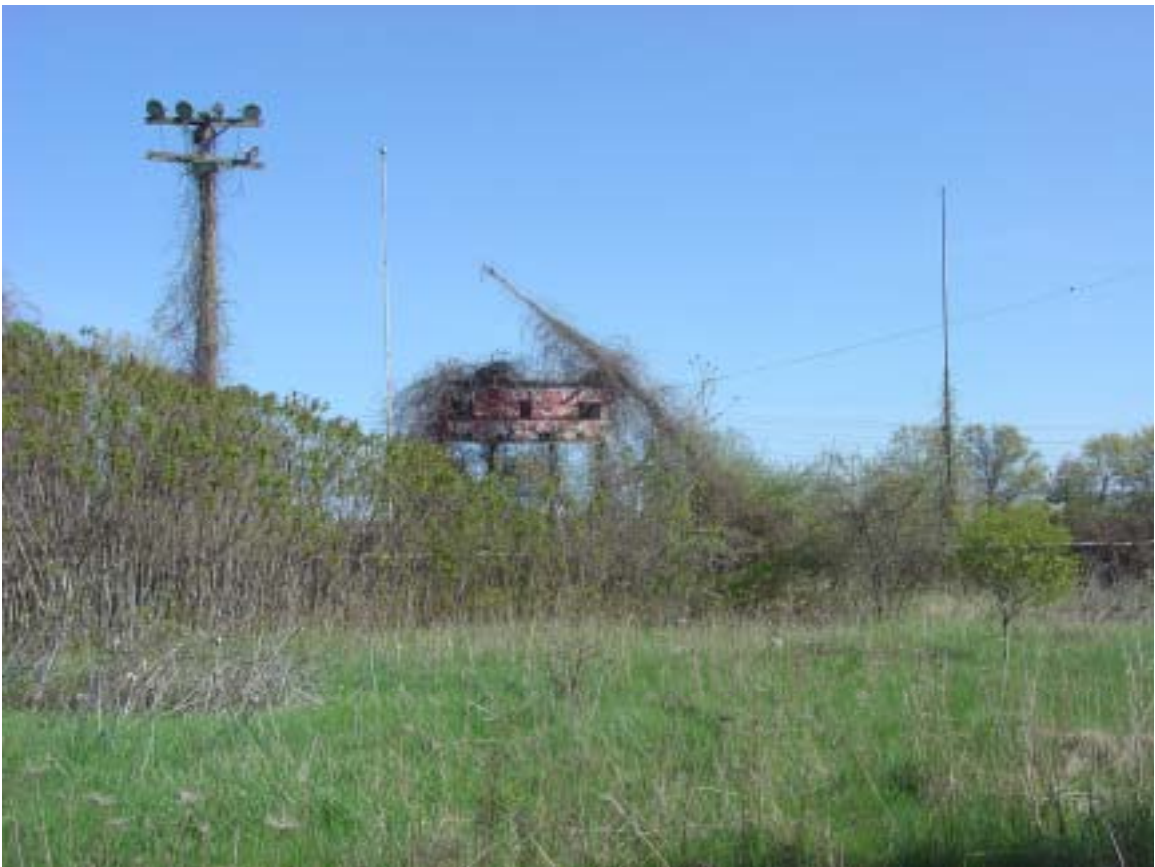
Moving to the northwest, towards the concession buildings and ball field, the area is heavily overgrown with vegetation and was difficult to observe or photograph in much detail. Old white goods including washing machines were dumped along the edge of the paved area. The vegetation is so severe that in places it is damaging old structures including flagpoles, and bleachers. See next 3 pictures.

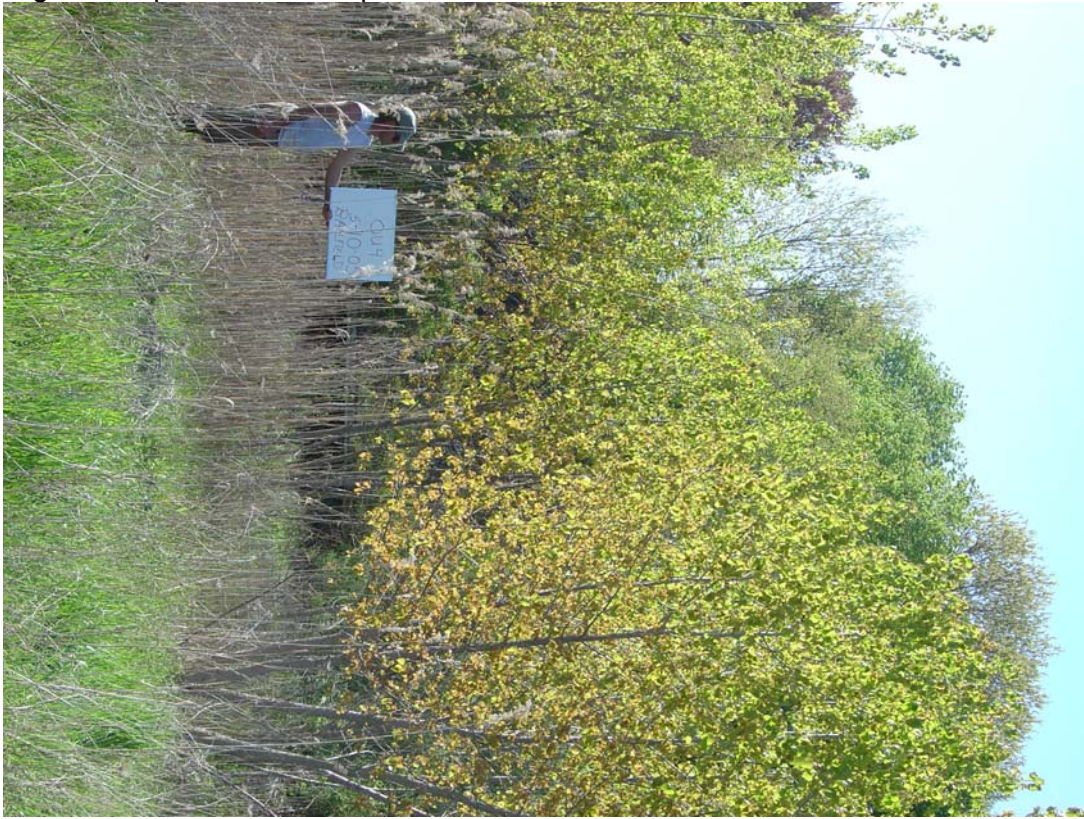
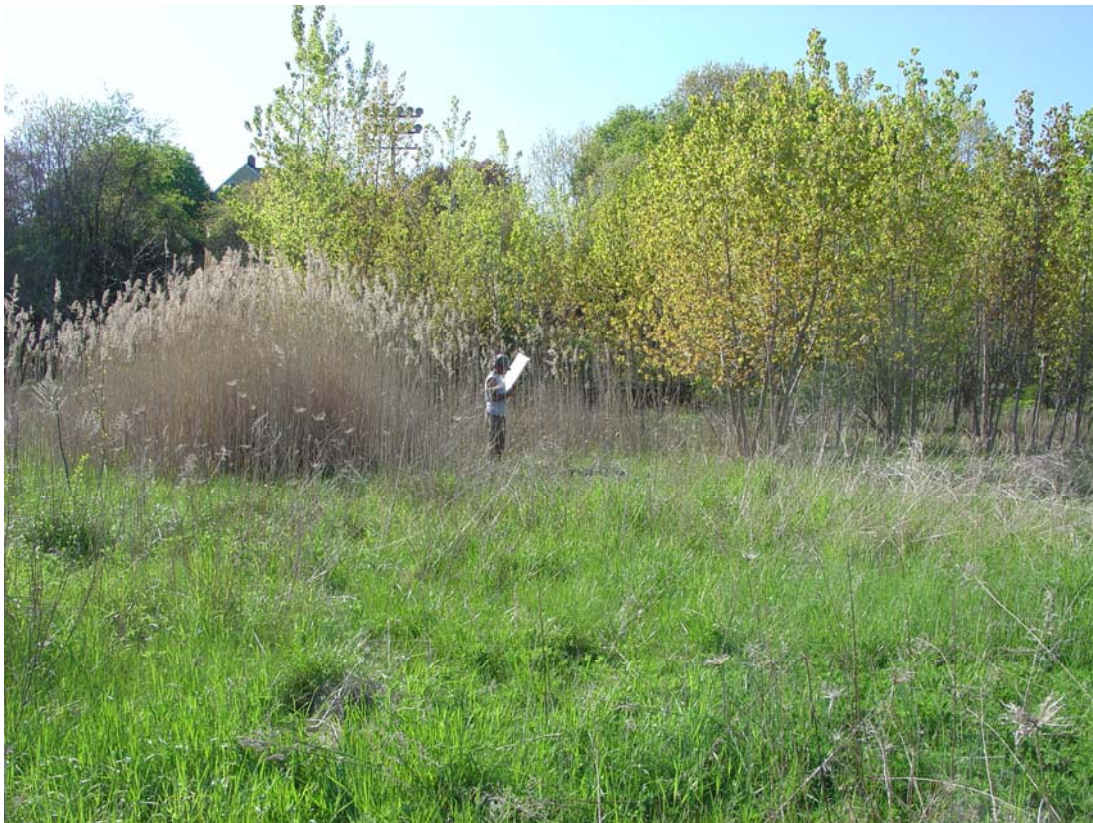
The interior of the ball field is a hummocky grass surface with shrubs and trees approaching 25-30 in height interspersed. Next 2 pictures.

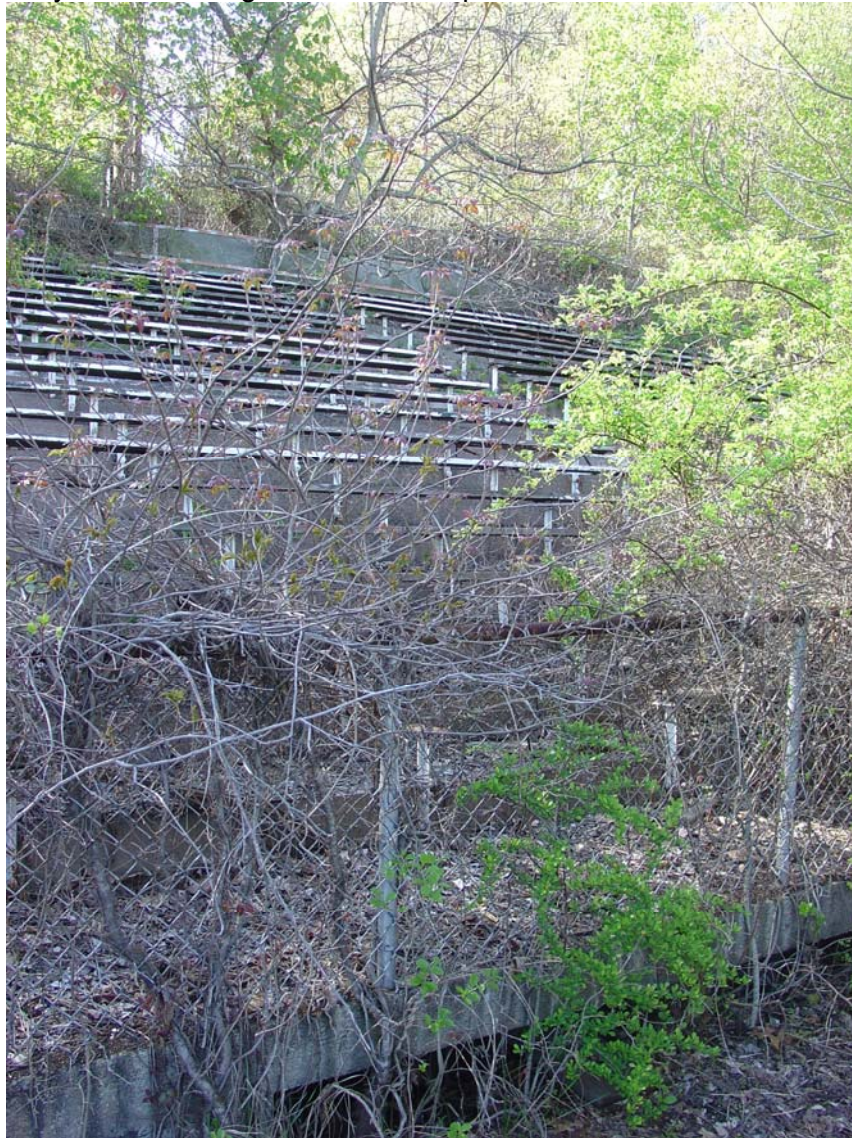
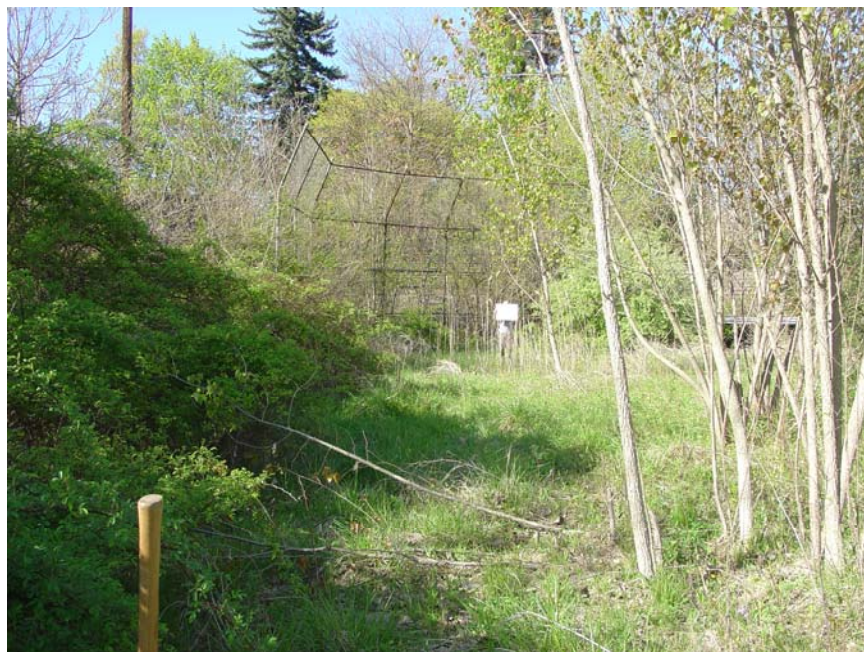
No attempt was made to climb the bleachers or check the interior of the structures due to condition and heavy vines and vegetation. Next 2 pictures.

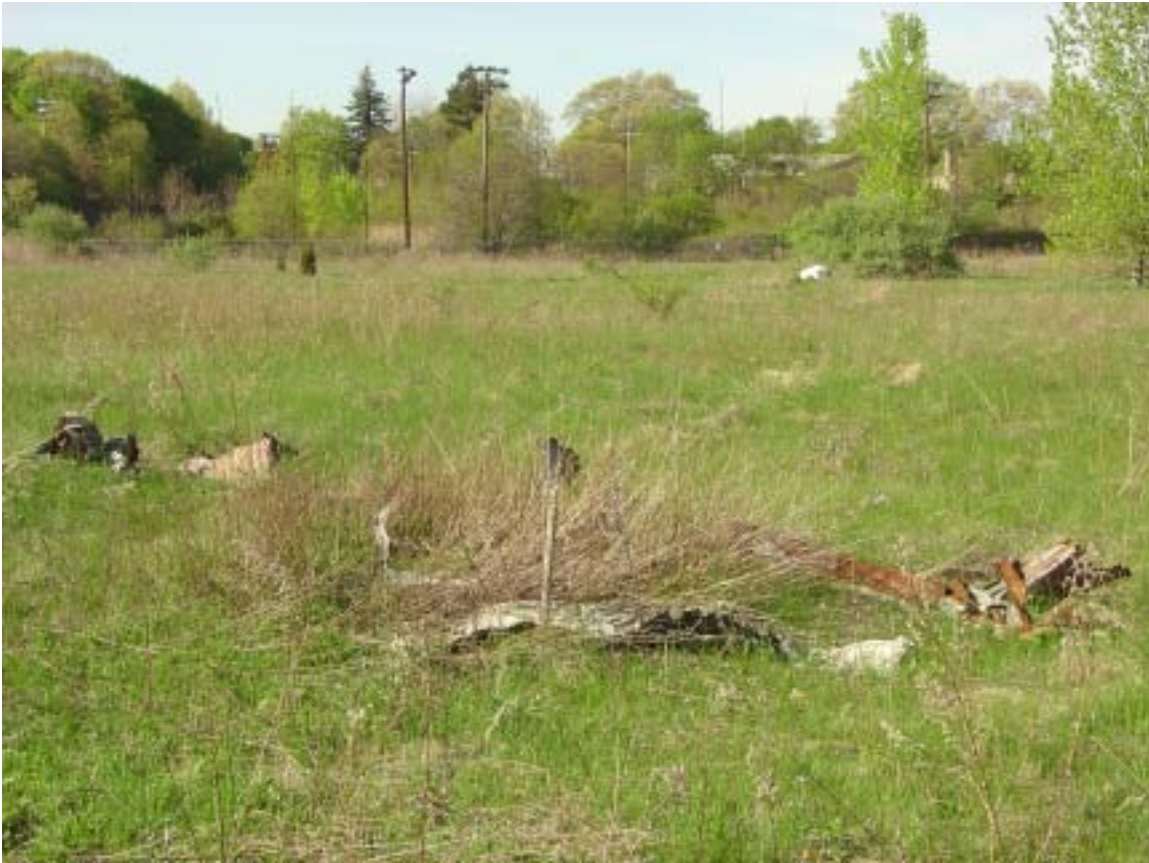
From this point we moved across the open grassy field to the south corner where the OU4 site abuts the railroad track and Contract Plating property. In general, the site is hummocky grass with occasional tree's and shrubs. As we moved to the south, signs of illegal dumping of wood, corrugated sheet metal, and more white goods were observed, especially in the area of monitoring well MW-6 (200-E). This photo is taken from that well looking back towards the ball field. Note the white washing machine beside the shrub.

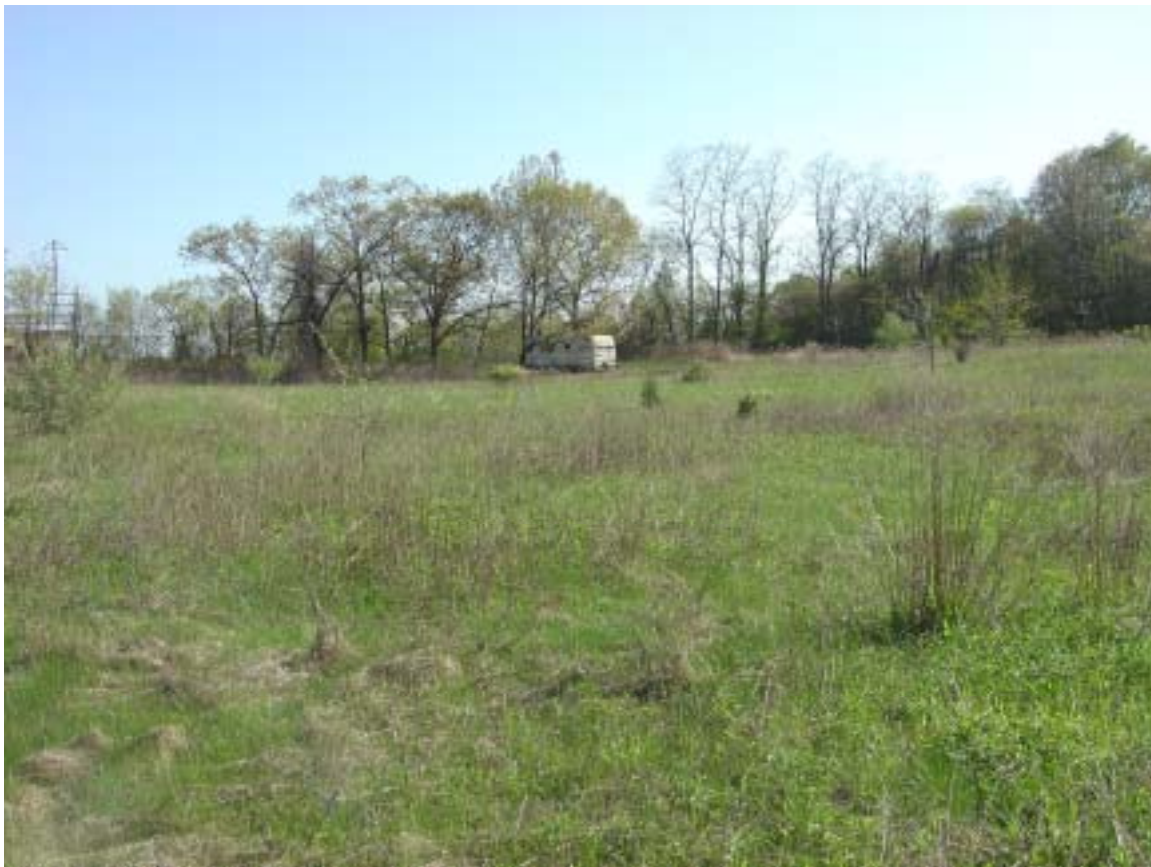
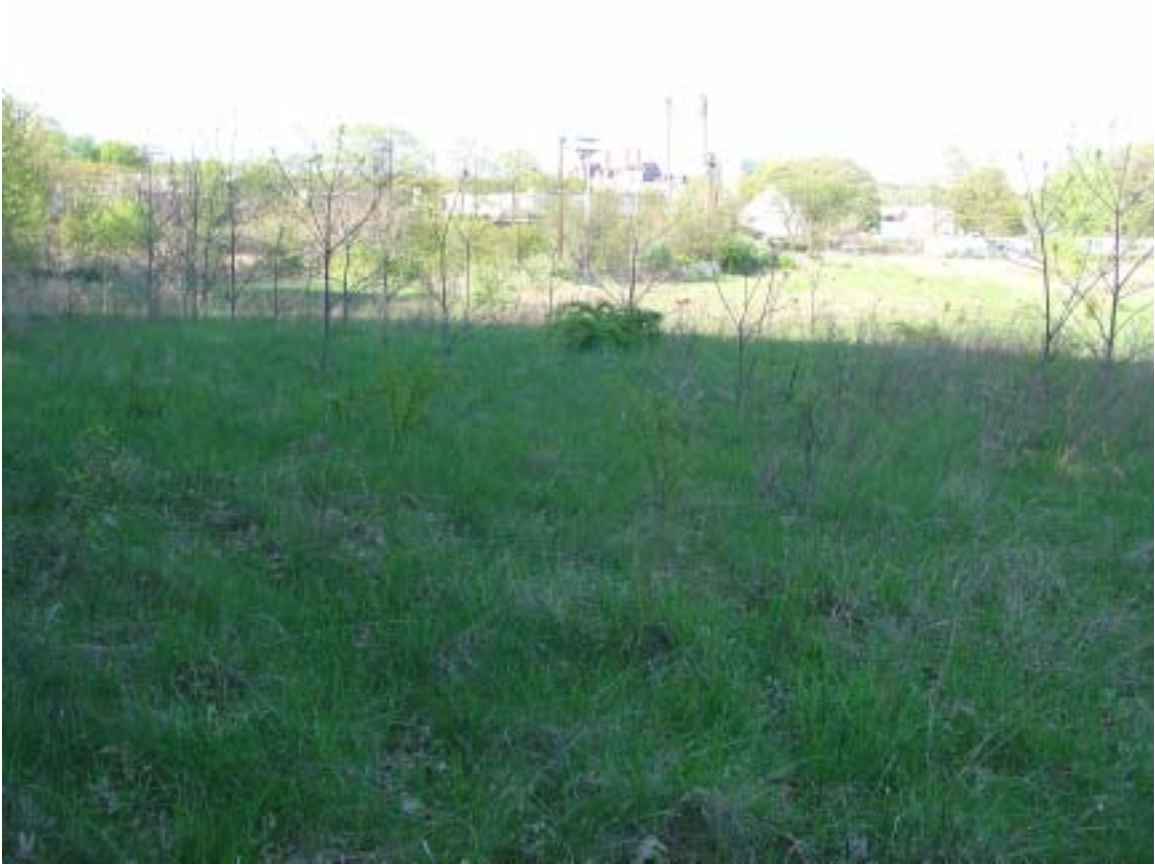
The site gate was locked once we completed our documentation. A few photos of the overall site are provided below.

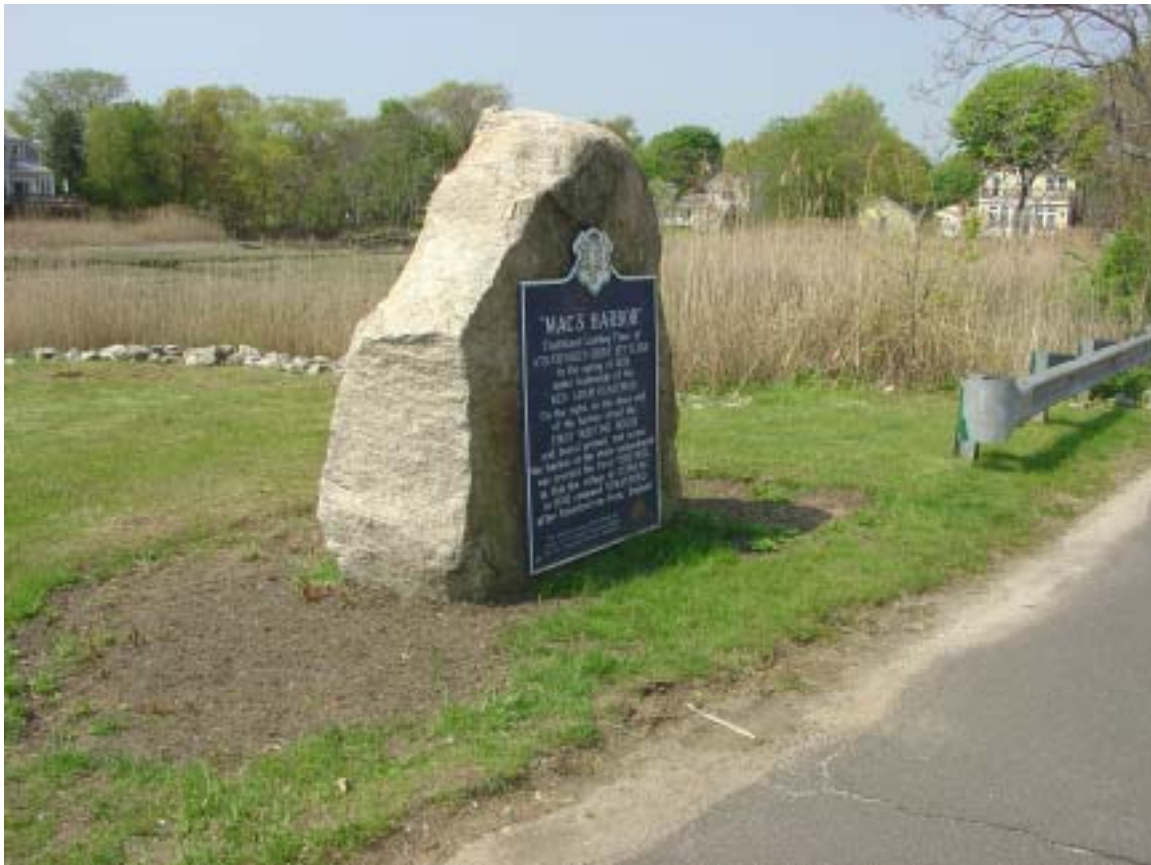
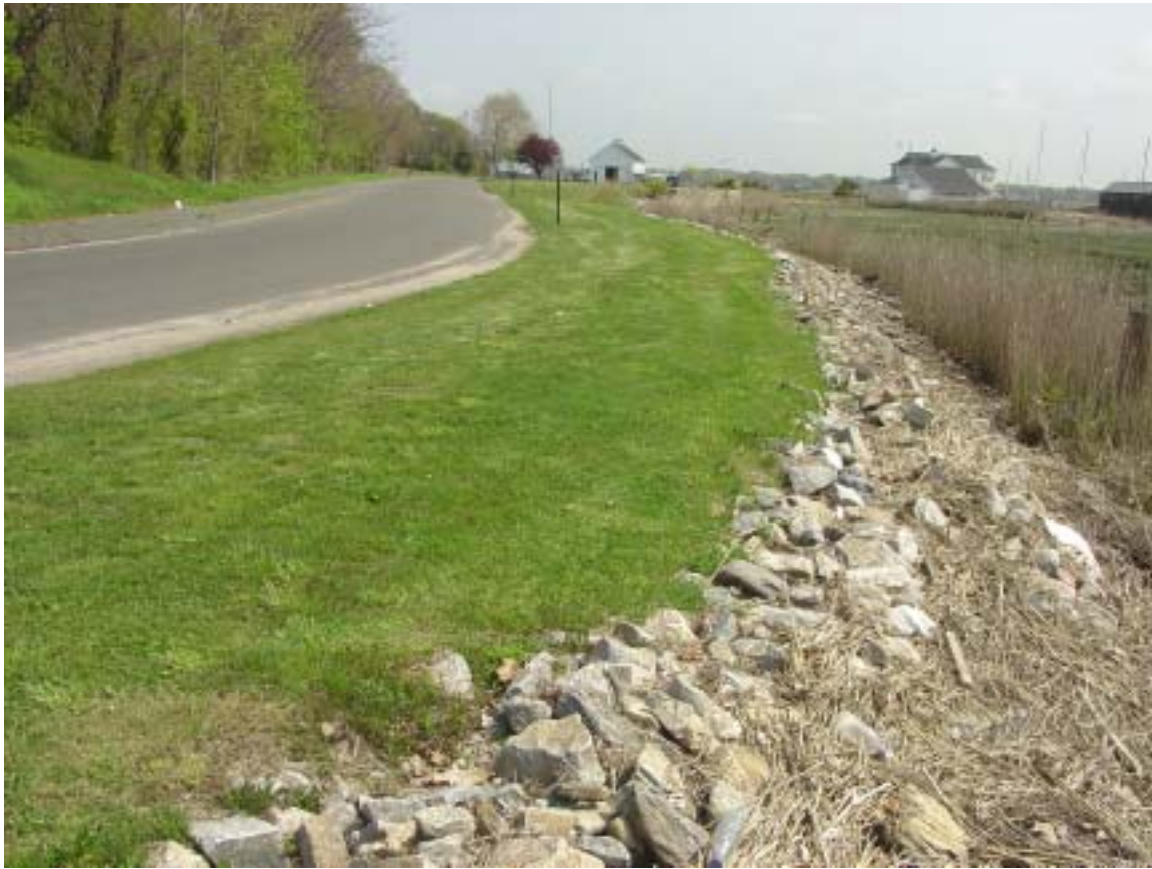
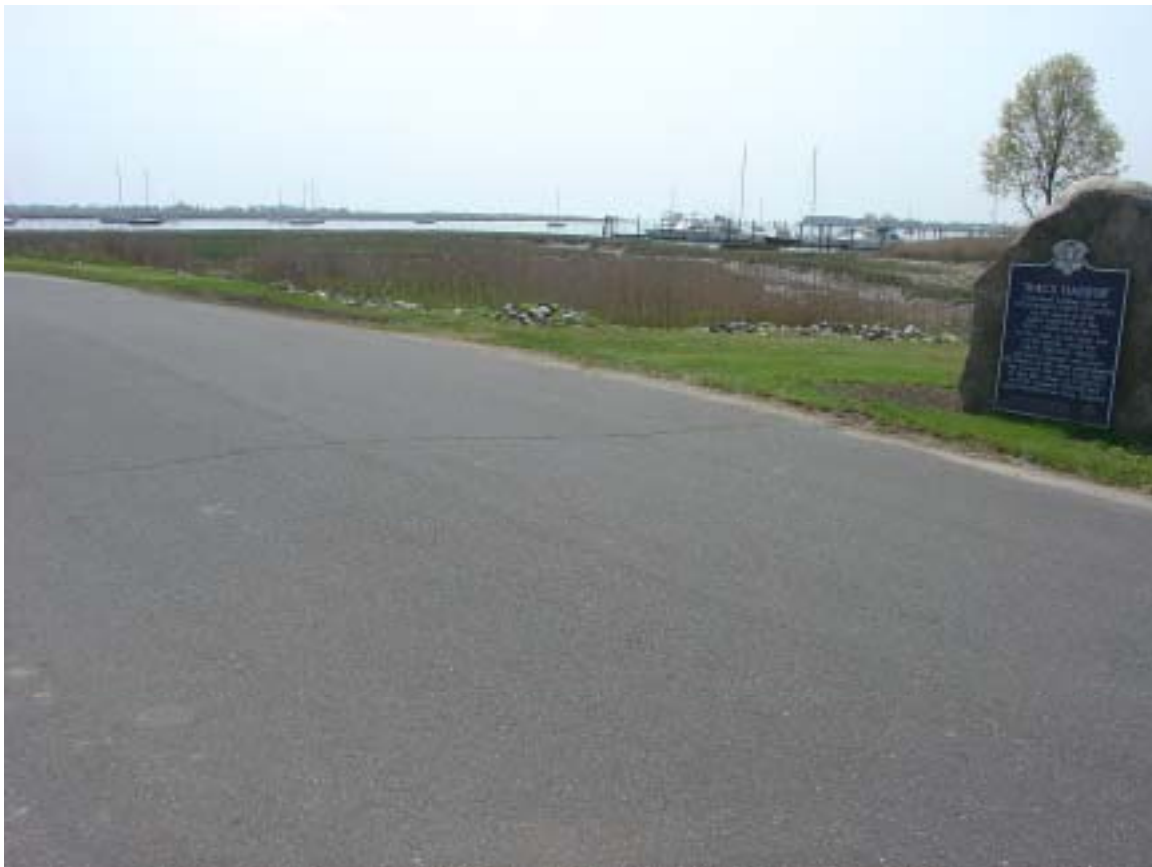
some of the geotextile material has been exposed throughout the site  
MW-5325 needs some minor repairs

The following photographs were taken during the site inspection and are presented in a counter clockwise fashion beginning at the entrance of the Housatonic Boat Club property.

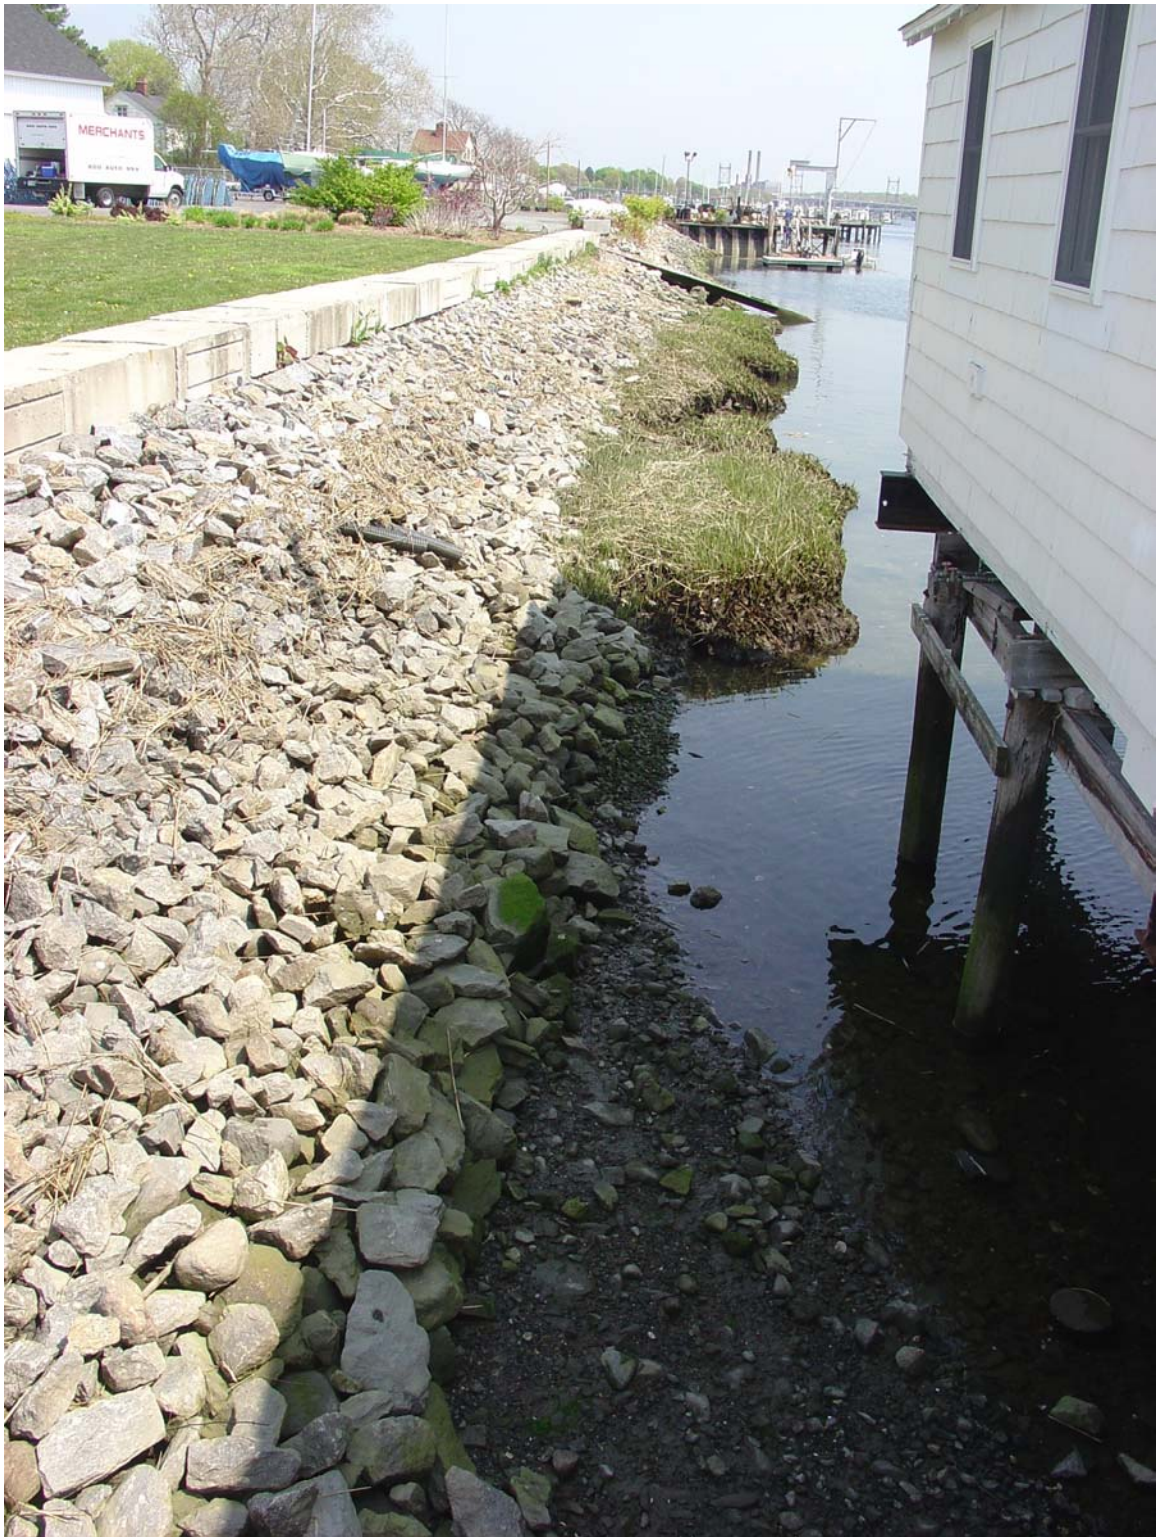
View looking north from main boat club building.
